BULIMBA STATE SCHOOL BRISBANE

HERITAGE REPORT: Section on history

Client: Department of Education and Training
Master Site Number: 20017
Address: 261 Oxford Street, Bulimba

Marie-Anne Ammons Architect Pty Ltd

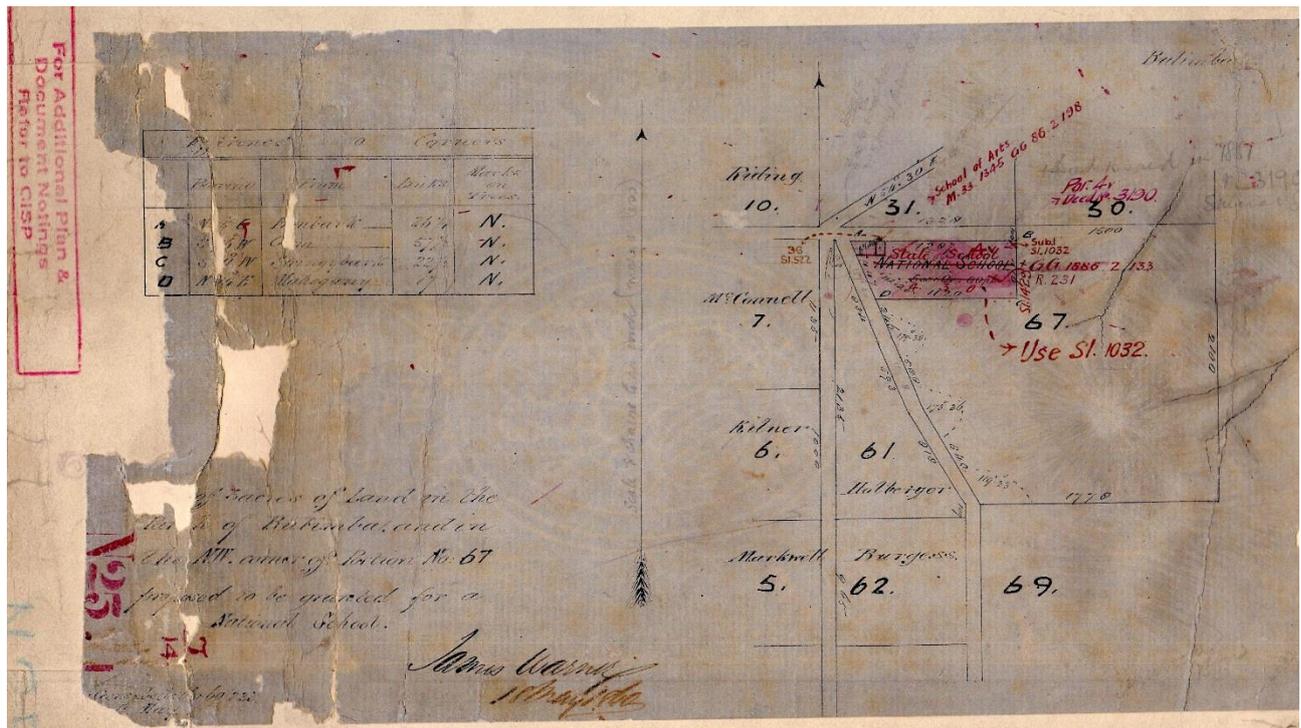
Figure 1: '[Survey] of 5 acres of land in the Parish of Bulimba and in the NW corner of Portion No. 67 proposed to be granted for a National School' signed by James Warner and dated 18 May 1860 (Mapping and Surveying Museum N25.1). The notes in red were added later and show a subdivision for the School of Arts and the Gazettal of Reserve 231 for Bulimba State School in 1886.

A five acre site for a National School at Bulimba was surveyed in 1860 on part of Portion 67. When Portion 67 was sold to G [George?] Harris, the first owner, in 1862 the land for the school was excluded from the sale. Portion 67 is shown on a plan dated 1858 and was slightly under 50 acres³. It was mostly steep with poor quality soil which would have been less attractive for farming.

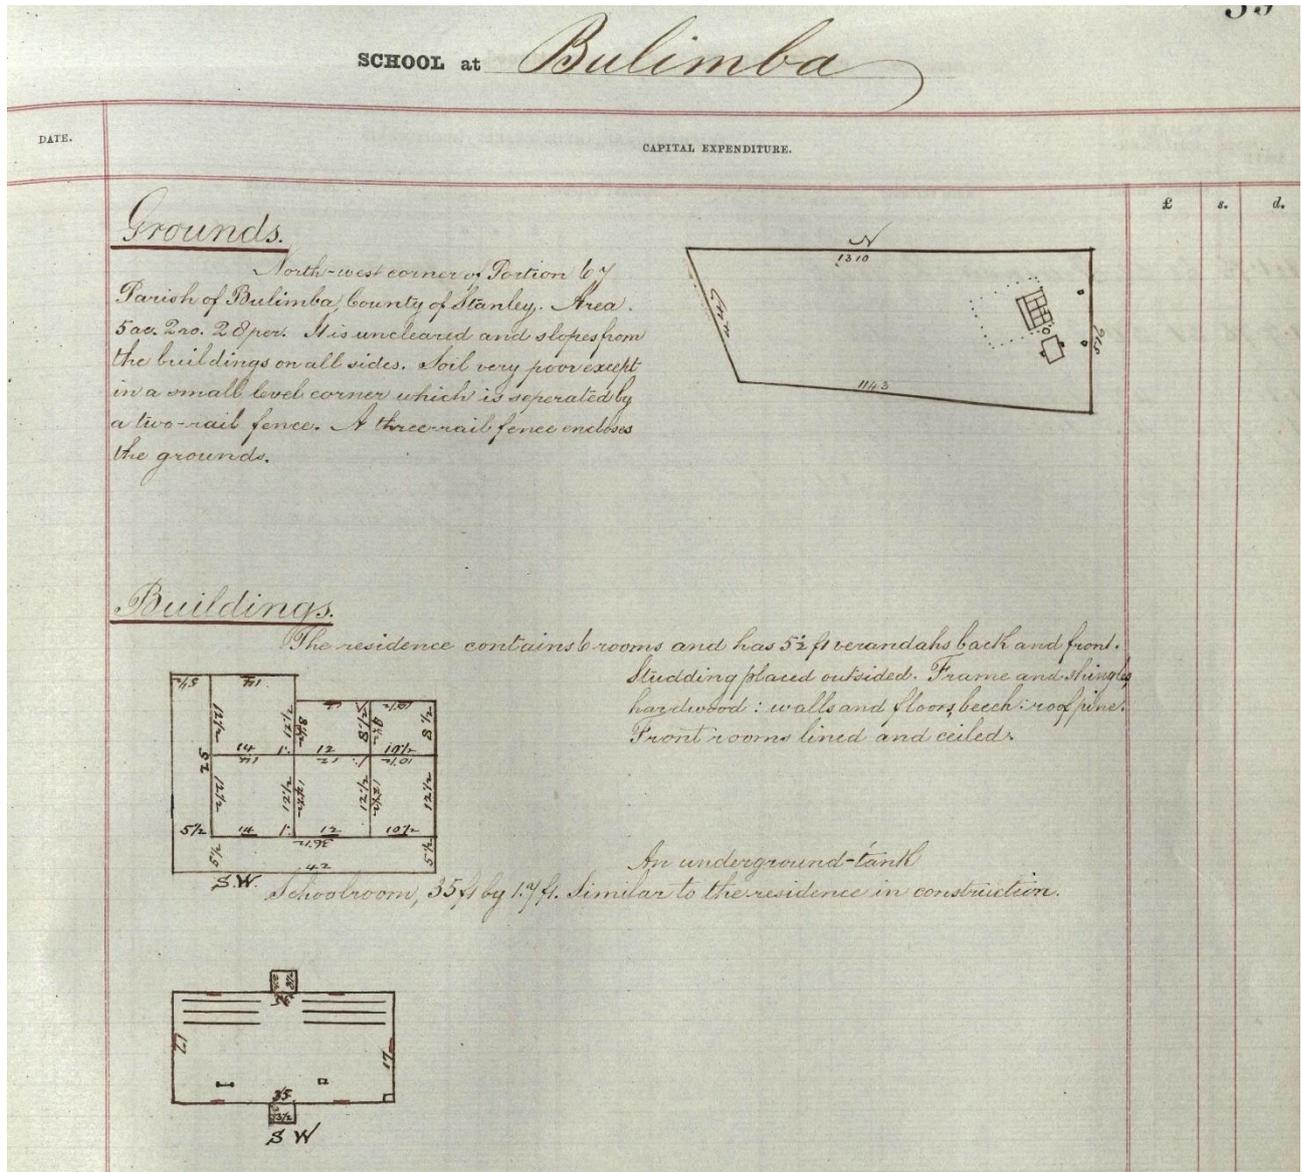
Figure 2 (above): Entry for Bulimba State School in the Register of Schools (Vol 2 p.39 QSA 13621) showing a sketch of the site 'north west part of Portion 67 5 acres 2 roods 28 perches' and the building layouts of the residence and school room. The alignment of the buildings reflected the topography, but they would also have faced towards the town centre of Brisbane. The school room layout was typical of the period with tiered seating.

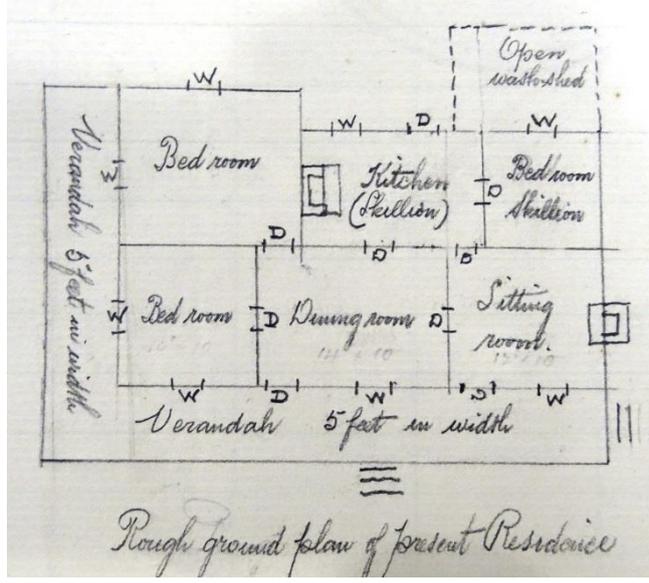
Figure 3 (left): Sketch of the residence in a report dated 20 February 1890, not long before the house was demolished (QSA 13998)

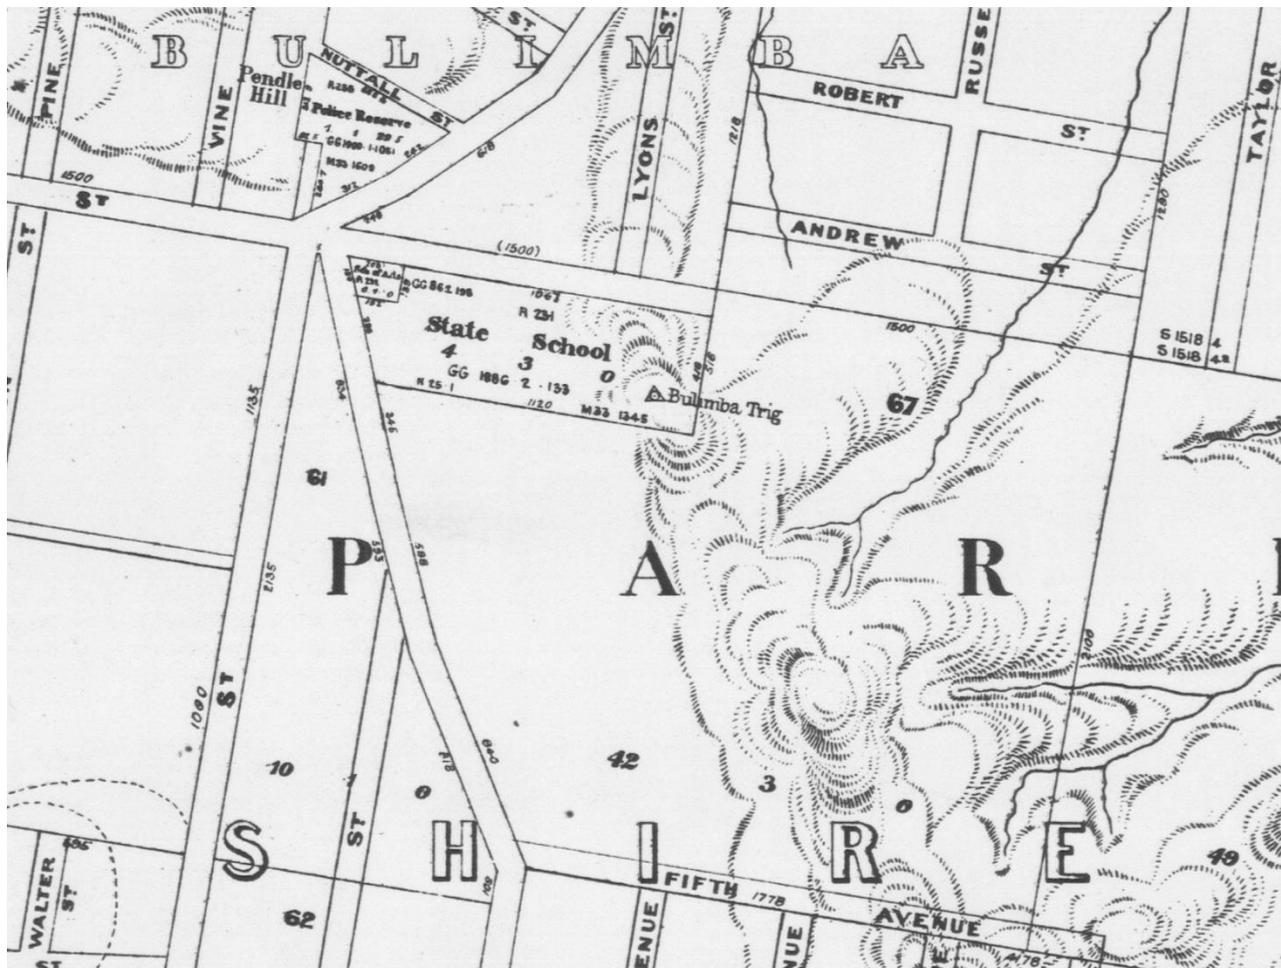
Figure 4: Excerpt from 8 chain map of Brisbane and Suburbs 1907 (Mapping and Surveying website). The steep land around the school remains undeveloped. Note the Bulimba trigonometric station from the trigonometrical survey of Brisbane standard circuit traverse 1895.

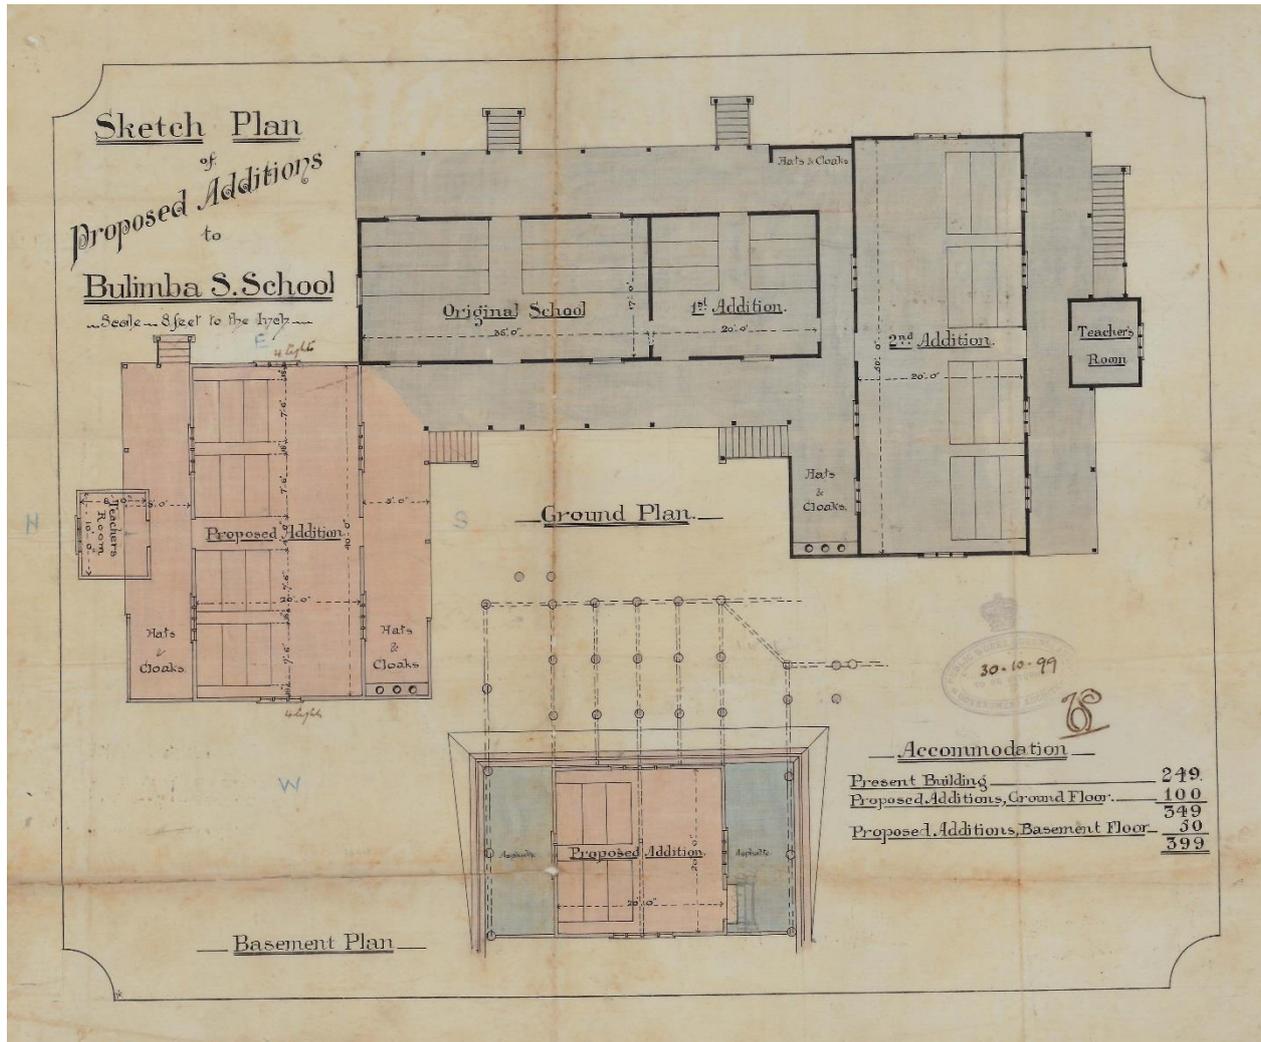
Figure 5: Proposed extension at the northern end of the original school, Department of Works drawing dated 1899. The first addition probably dates to 1884 and the second (at the southern end) to 1888 (QSA 13998)

- 1874 rebuilding underground water tank and inserting antcaps on building stumps;
- 1874 additions to the residence;
- 1877 addition of verandahs to the school and another fireplace to the residence;
- 1884 addition to the school and replacing shingle roof with iron;
- 1886 construction of a playshed;
- 1886 Reserve for School of Arts excised from the north west corner of the site;
- 1888 additions (probably a new wing to south end of the school);
- 1892 residence apparently moved on site to make a level play area;
- 1897 residence replaced with a new house;
- 1903-4 addition of new wing to the north end of the school perpendicular to the original building. Plans initially prepared in 1899 – two storey unlined internally with vertical studs. Classroom 20ft x 40ft with teacher's annexe. Plans show original school 35ft x 17ft with

first addition at the south end [called the gallery room in 1901 report]. Second addition is 20ft wide x 50 ft with a teacher's room also to the south.

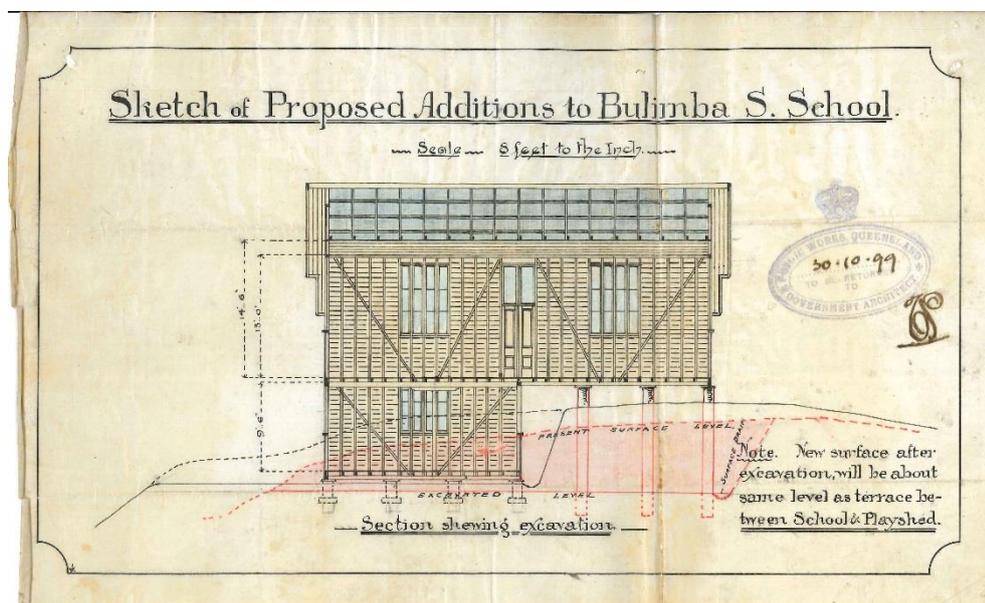
Figure 6: Section of new wing showing internal walls unlined and tall windows (QSA 13998).

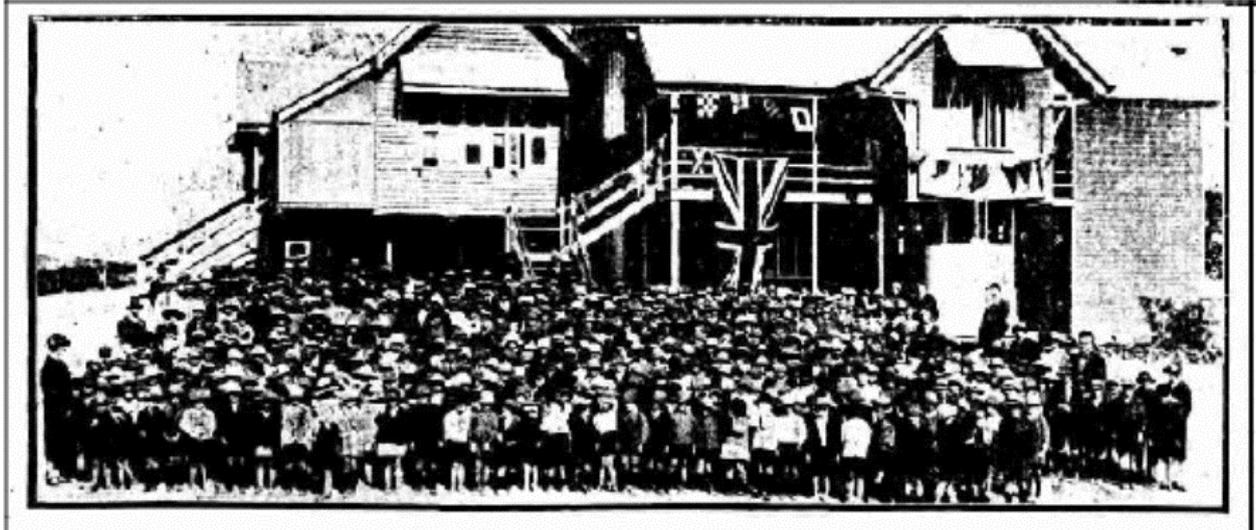
Figure 7: Photograph Bulimba School from the Brisbane Courier 17 July 1926. The block at left would be the original school building raised and modified. The block at right was built in 1904.

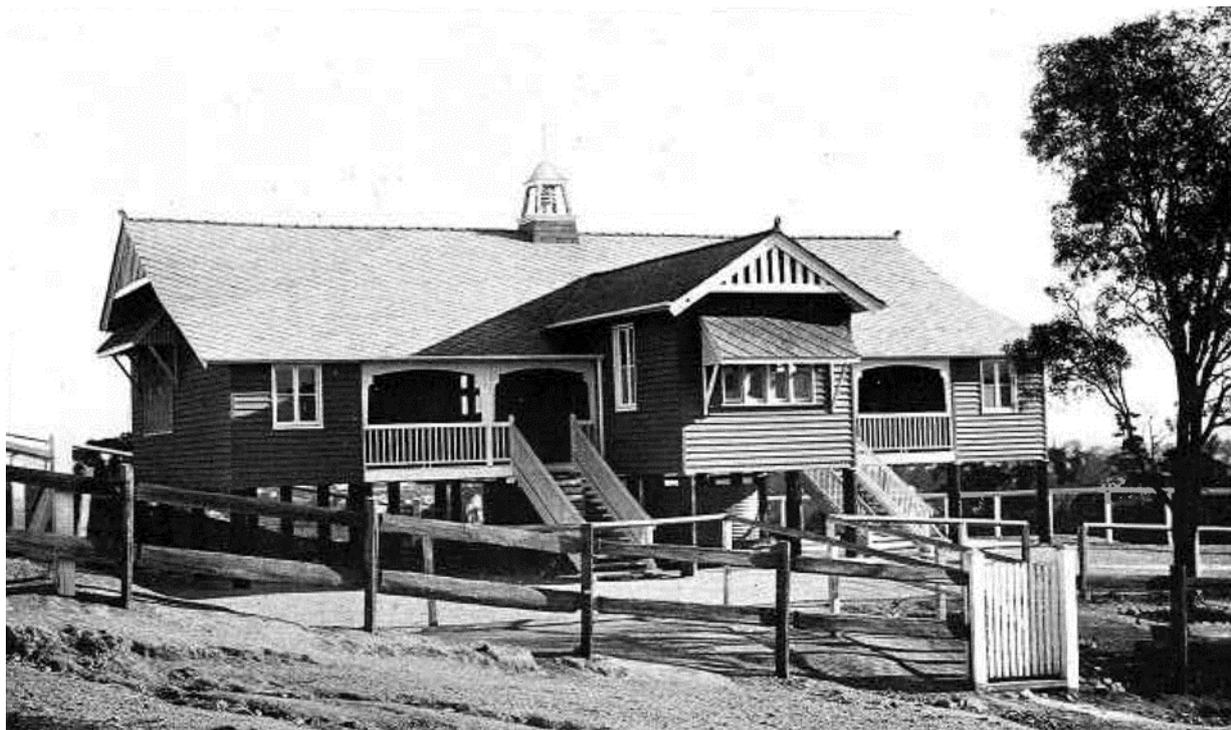
Figure 9: Bulimba Infants' school in 1915 viewed from Oxford Street (illustrated in Department of Public Works Annual Report 1915 plate 6). The projecting gable is the teacher's annexe and the ends of the front verandah are enclosed for hat rooms.

The Bulimba Infants' School was one of these new building types. No original plans have been found but plans for the 1952 'Reconstruction' combined with evidence from the photograph in figure 9, suggest that the new building was characteristic of timber classroom blocks designed by the Department of Works after 1909, except it had a verandah on one side only.

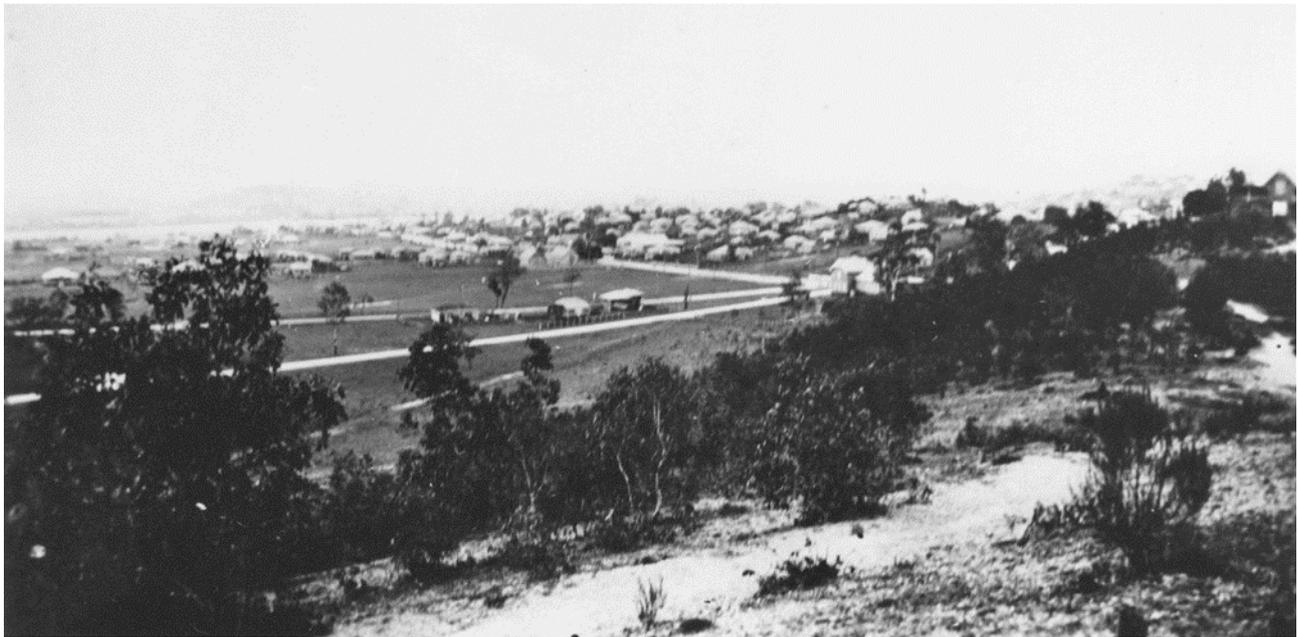
Figure 10: View of Bulimba from the south east (JOL 88030 excerpt). The timber school can be seen far right at the top of the hill. The School of Arts is visible at the junction of the three roads. This photo is dated to the 1920s in the archive and certainly dates to after 1914 when a second storey was added to the School of Arts.

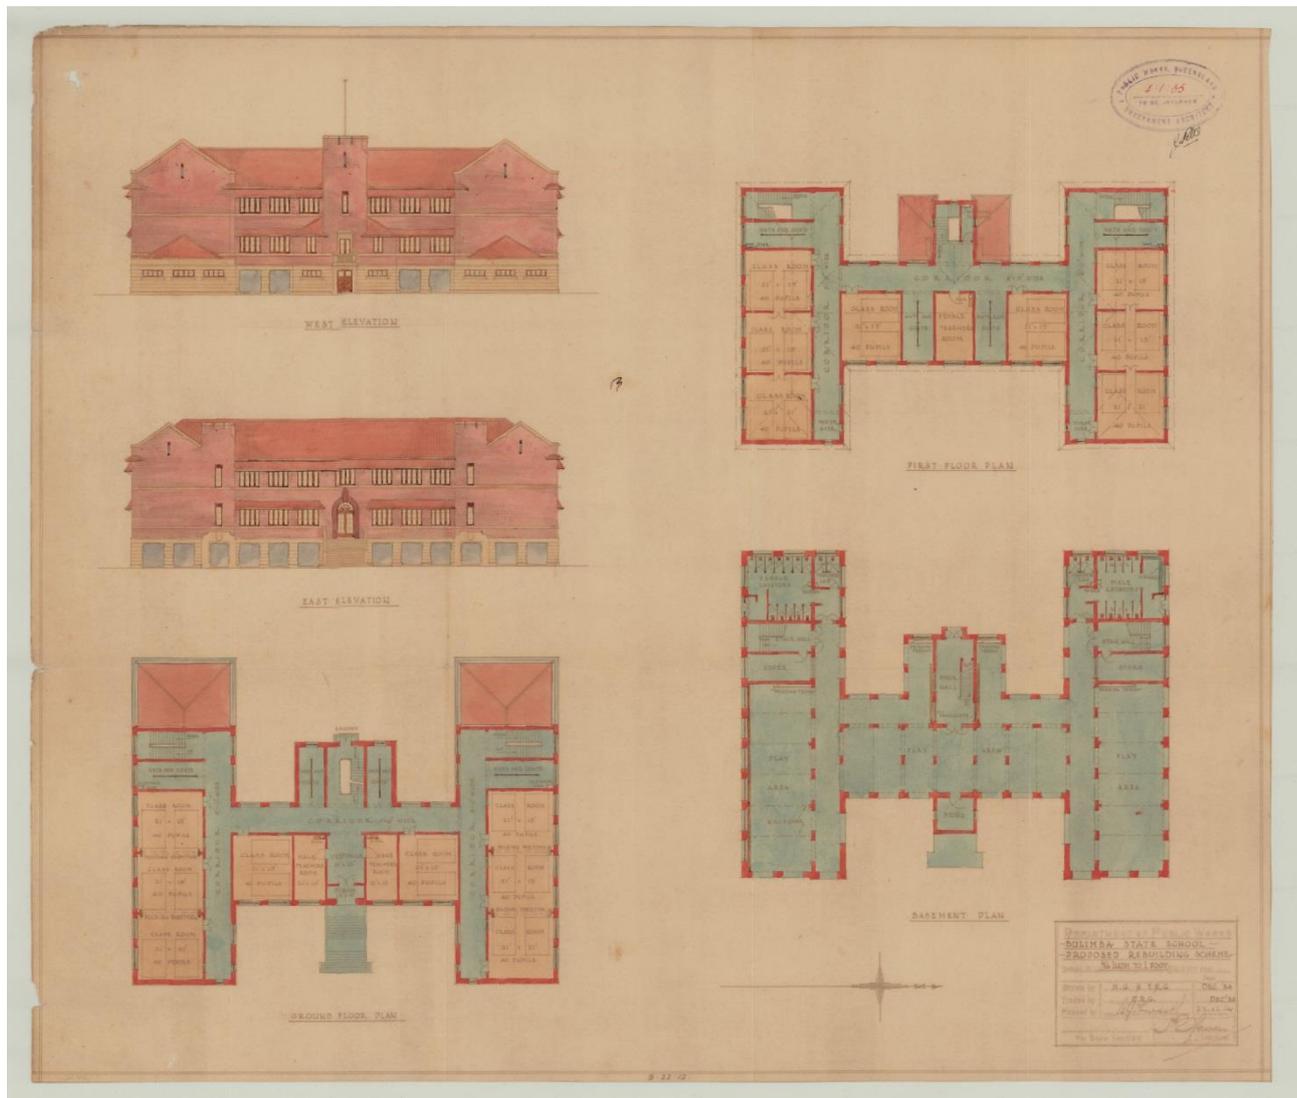
Figure 11: 'Proposed Rebuilding Scheme' Department of Works drawing December 1934 (QSA 125477 Box 24)

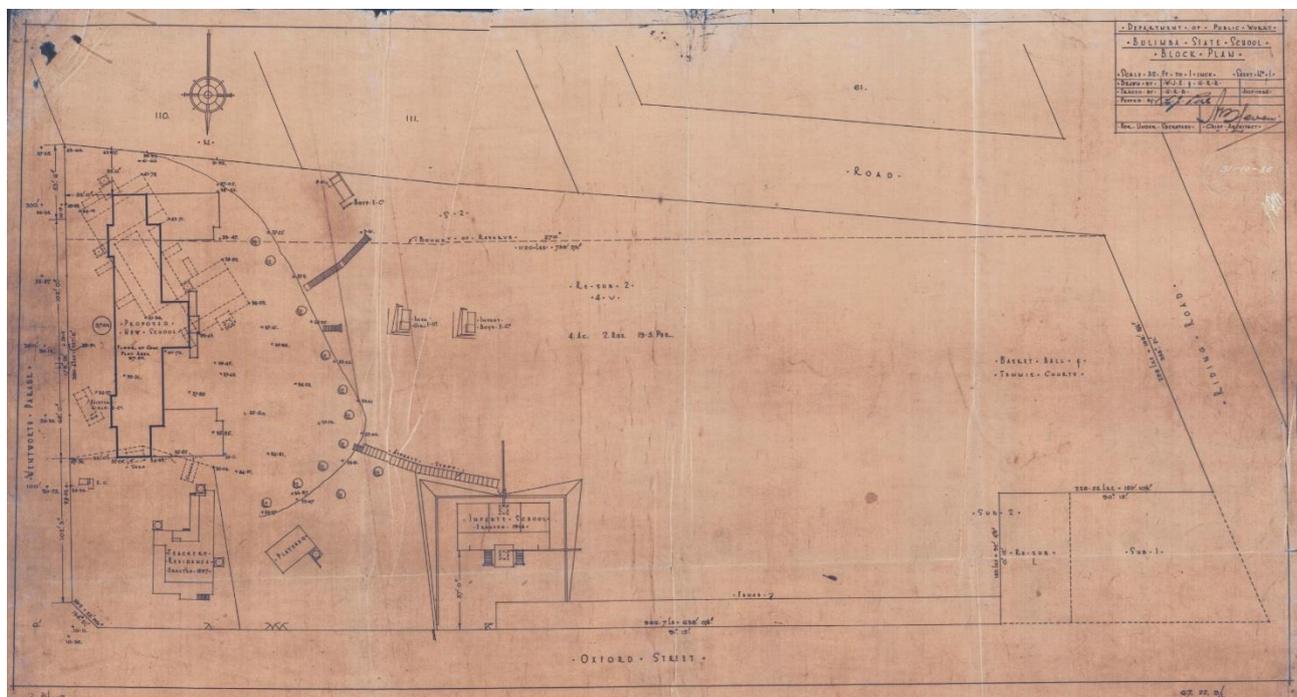
Figure 12: Block Plan July 1935 (QSA 125477 Box 24 blue print with colours reversed for legibility).

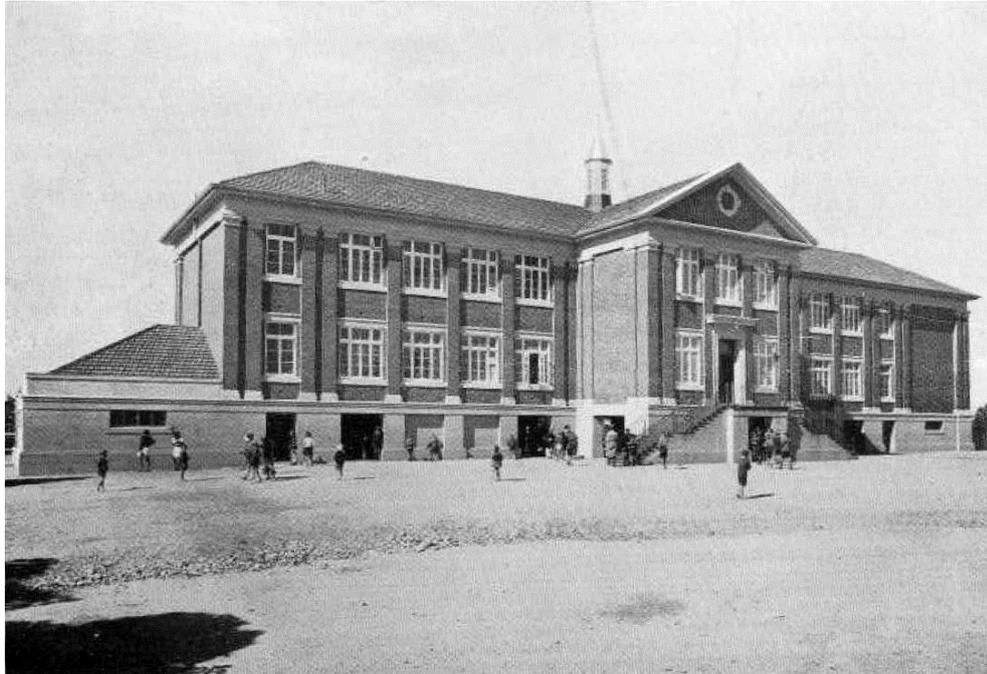
Figure 13: Block A western elevation published in the Department of Works Annual Report for 1938. The north extension has not yet been built.

'The new Building, situated on the crown of the Bulimba Hill, faces west and is bounded on the North by Oxford Street, and on the East by Wentworth Parade. The structure is of three (3) stories, built of brick and concrete with cement facings. The roof is covered with the "Marseilles" pattern roofing tiles, and is surrounded [sic] at the centre with a fleche. The new structure replaced the old wooden buildings. The building contains thirteen (13) classrooms situated on the ground and first floors, accommodating five hundred and twelve (512) pupils. A Head Teachers room, two (2) Teachers' rooms and four (4) hat and

cloak rooms are also provided. The classrooms on ground and first floors are provided with folding partitions. Lavatories for male and female teachers, boys, girls and infants, also store rooms are situated in the basement, the remainder of this floor being utilised as a play area. A complete drainage and septic tank installation is included. The grounds have been levelled and graded as required with retaining walls to Wentworth Parade and Oxford Street. Tennis courts have been built on the site previously occupied by the Head Teacher's Residence. The cost of the new Building and retaining walls to date is £25,463.'

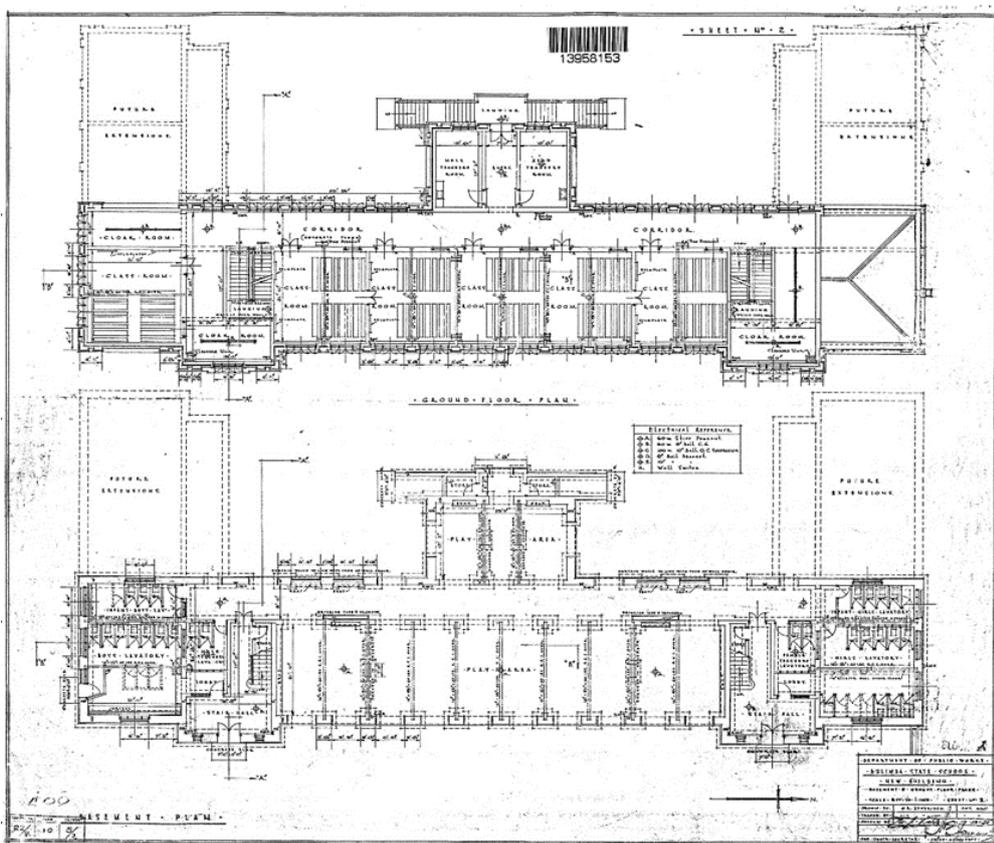
Figure 14: New Building, basement and ground floor levels, Department of Works Oct 1935 (eplan 13958153).

A specification was prepared in August 1936 (see summary in Appendix 5.3). The construction was of high quality and included solid and cavity brick walls, reinforced concrete lintels, sills and copings, floors either of suspended concrete finished with a non-slip carborandum finish or timber

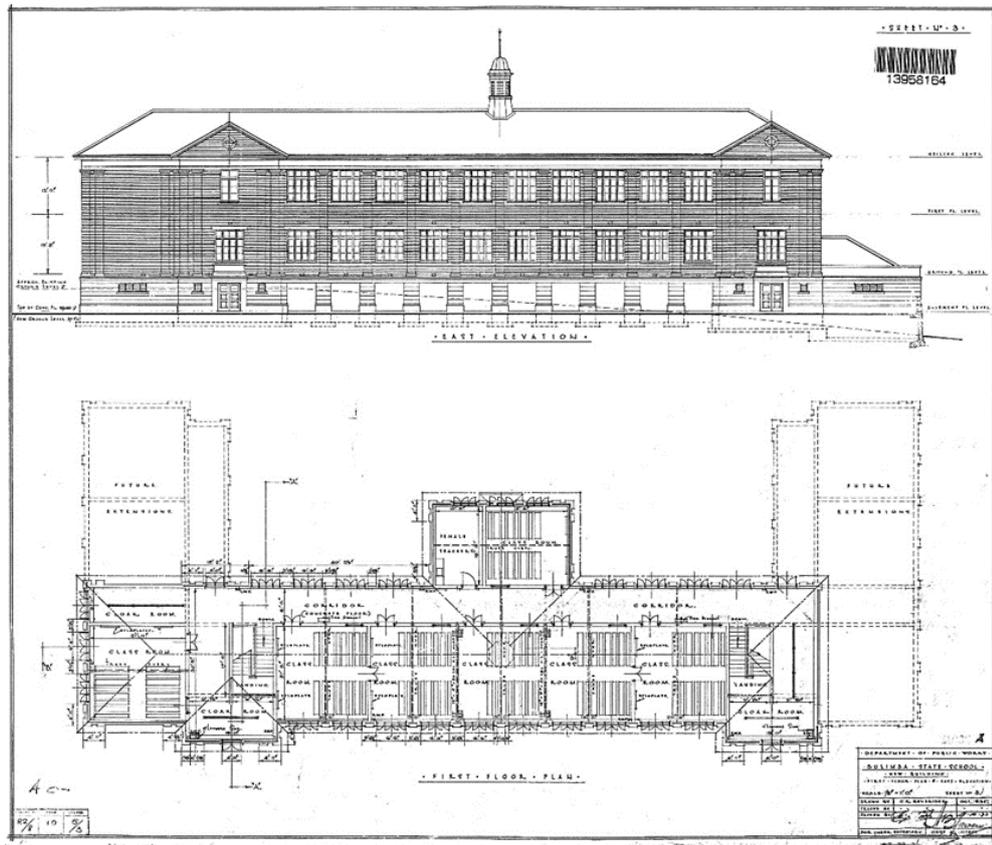
Figure 15: Bulimba State School, New Building, East Elevation and First Floor Level Department of Works October 1935 (eplan 13958164).

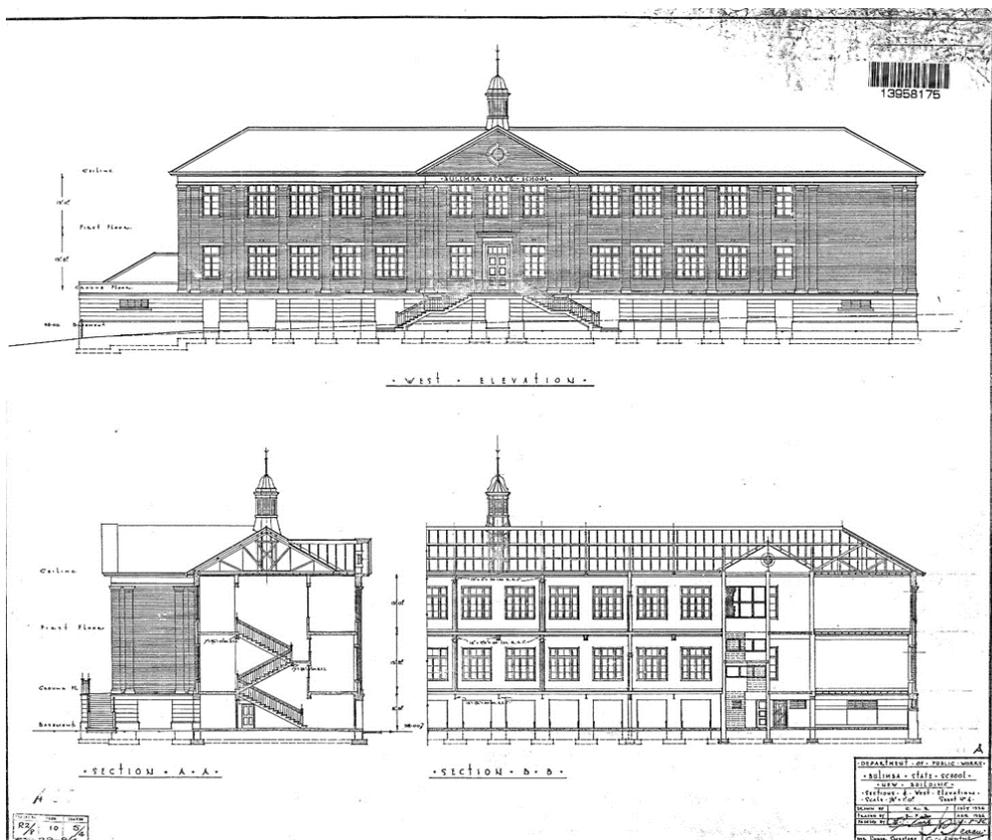
Figure 16: Bulimba State School, New Building, Section and West elevation Department of Works July 1936 (eplan 139 58175).

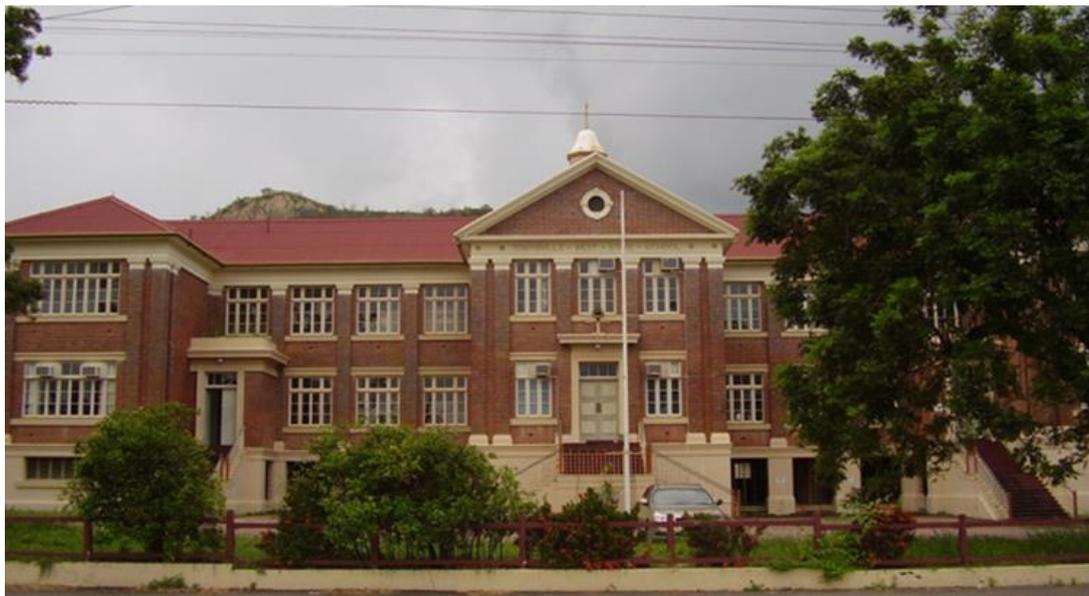
Figure 17:
Exterior of
Townsville
West State
School in
2011.

The exterior of the school bore striking similarities to Townsville West State School constructed 1937 – 1938¹⁵. RP Buchanan was probably the designer of this school within Department of Public Works. This school had projecting wings at each end, like the extensions proposed for Bulimba.

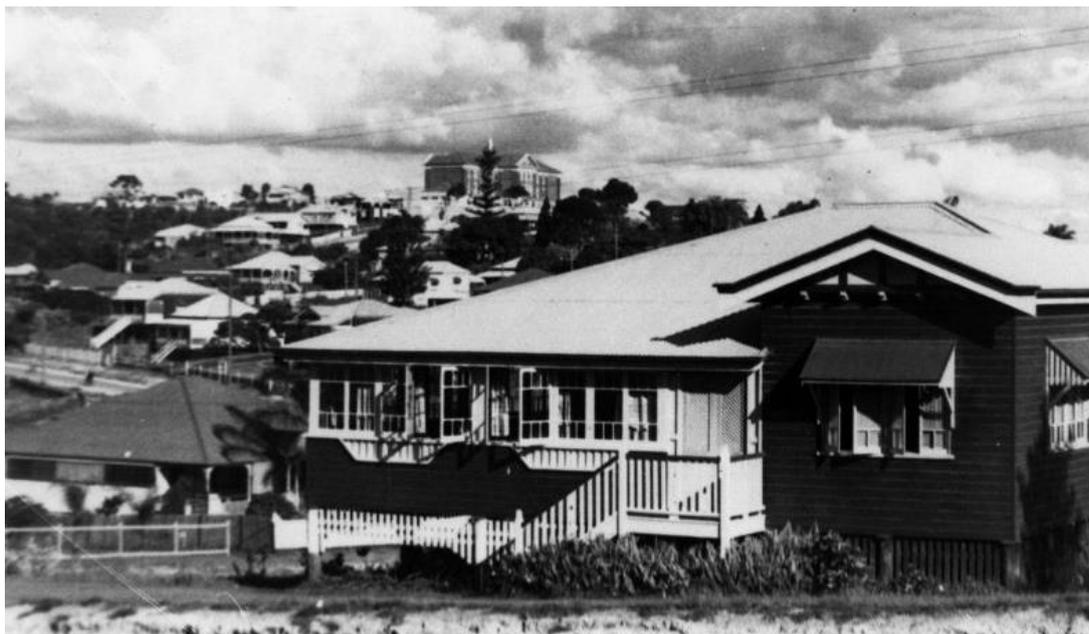
Figure 18:
View from
the north
west before
1958 with
Block A on
the skyline
(extract JOL
negative
168416)

Like many of the large brick schools built between the wars, the new school building at Bulimba was a prominent landmark on the skyline.

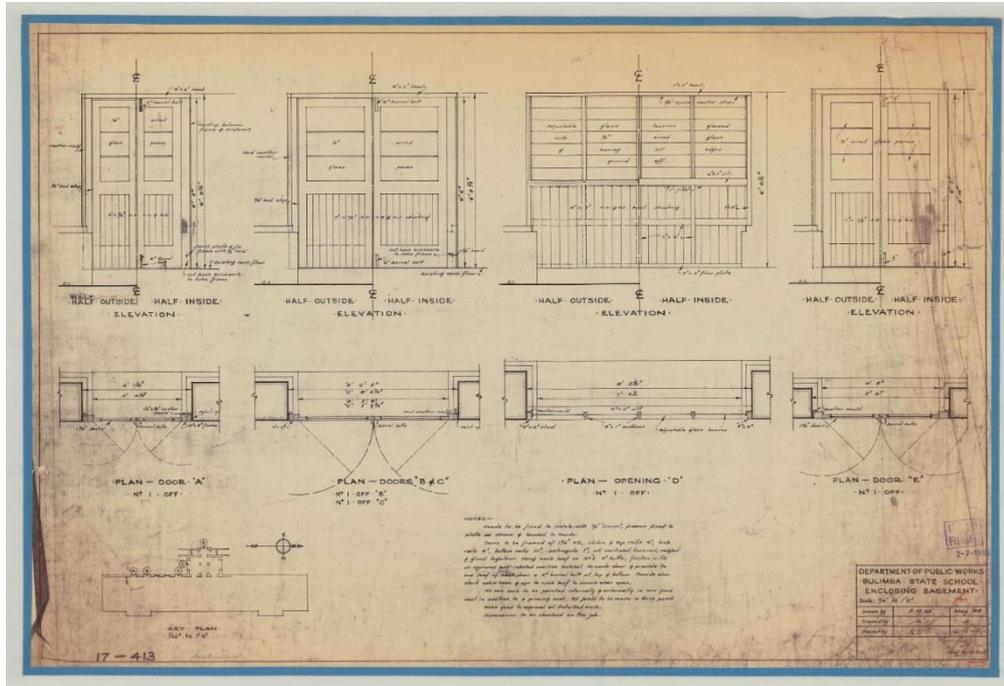
Figure 19:
 Proposed enclosure of south west part of the basement of Block A May 1948 (QSA 585673)

As a temporary measure the basement of Block A was partially enclosed in 1941 to provide more seating. Additional classrooms were not constructed until after the War.

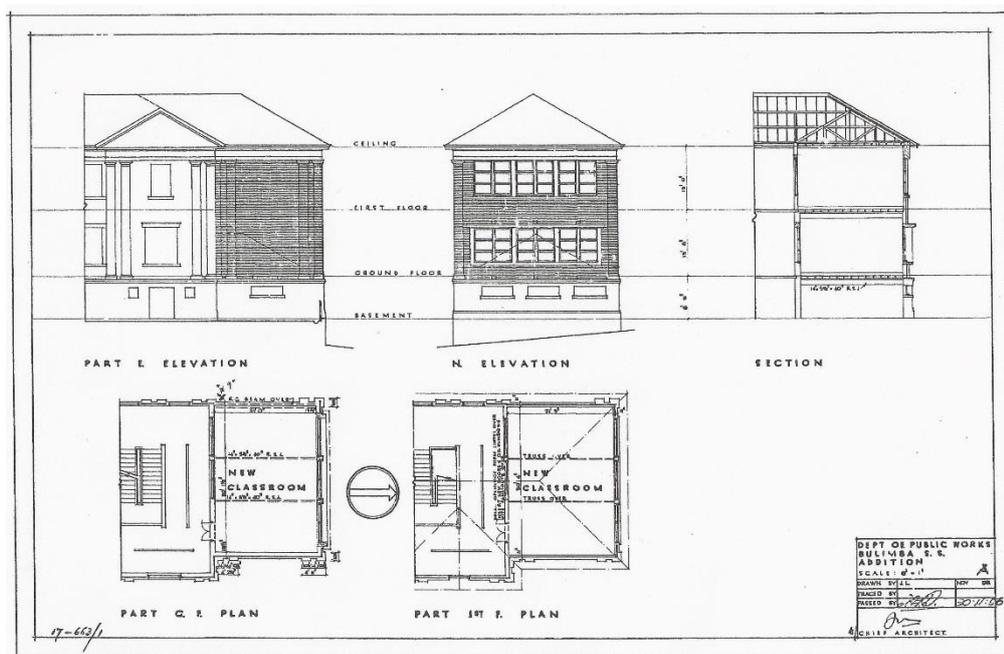
Figure 20:
 Addition, Department of Works 30 Nov 1956 [EHP]

In 1955 construction of two classrooms was approved at the north end of Block A above the single storey toilet facilities. The brick was closely matched to the original, as was the tiled roof, but the windows installed were banks of hoppers in accordance with post war standards. The extension was constructed in 1957

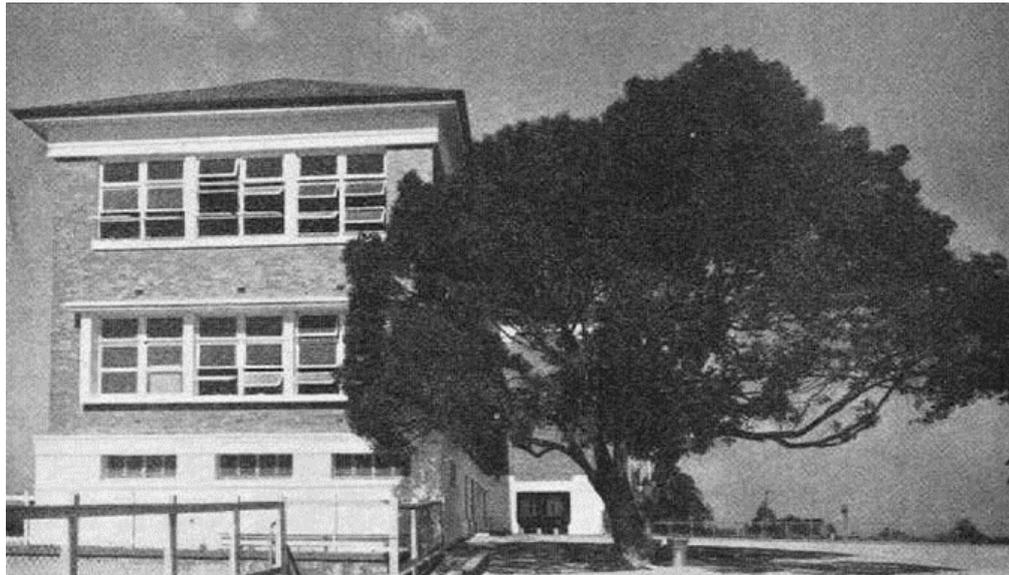
Figure 21: The northern classroom extension (Department of Works Annual Report 1958).

The image above shows a camphor laurel tree (which survives) and the original timber and chainwire fence which would have extended around the upper terrace.

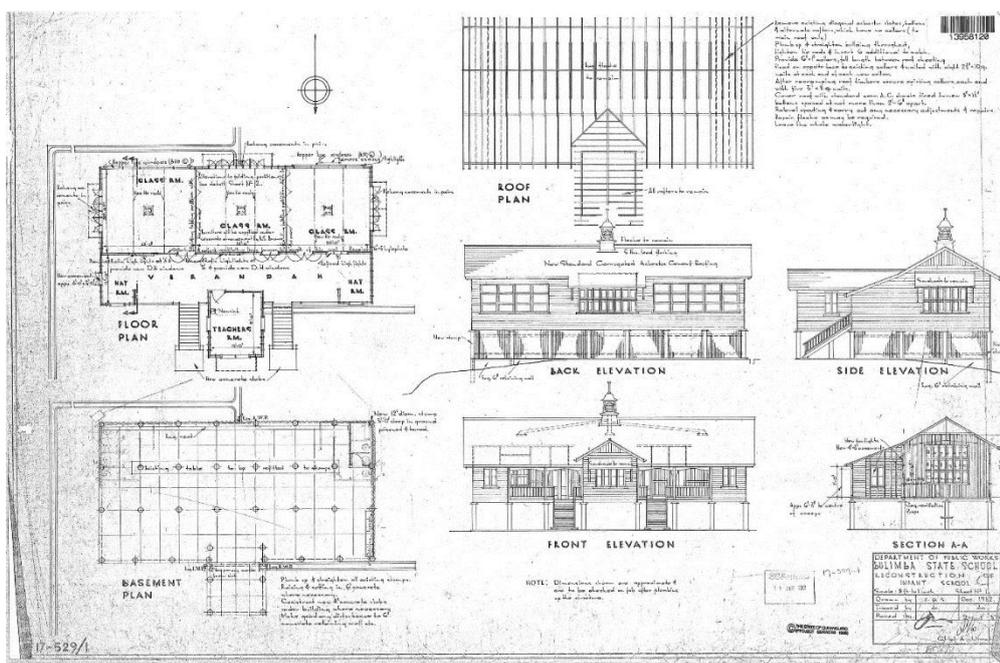
Figure 22: Reconstruction of Block C 1952 (eplan 13958120). The new hopper windows are visible in the rear elevation.

By 1952 the Infants' School was in poor condition with a leaking roof and racking of the roof framing possibly due to subsidence of the stumps. Plans were prepared for the replacement of the asbestos cement tiles in Super Six, for alterations to the roof framing and folding partitions between classrooms and for the installation of additional hopper windows in the south wall, in accordance with post war classroom standards. This work was carried out in 1954 at which time the fleche was removed.

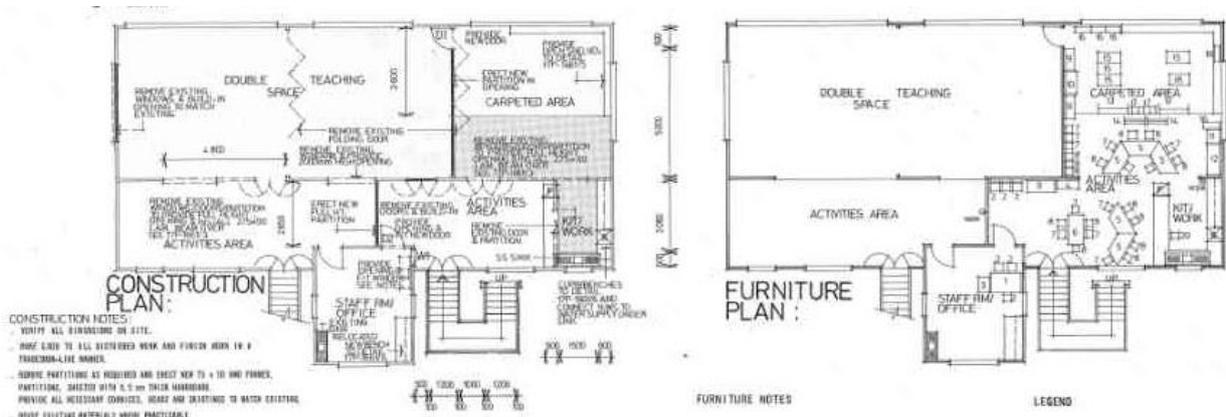
Figure 23: Alterations proposed to Block C in 1981 (eplan 11802307)

Block C was again remodelled in 1983 at which time most of the classroom wall to the verandah was removed, the folding partitions were removed and the 1915 window sashes were replaced.

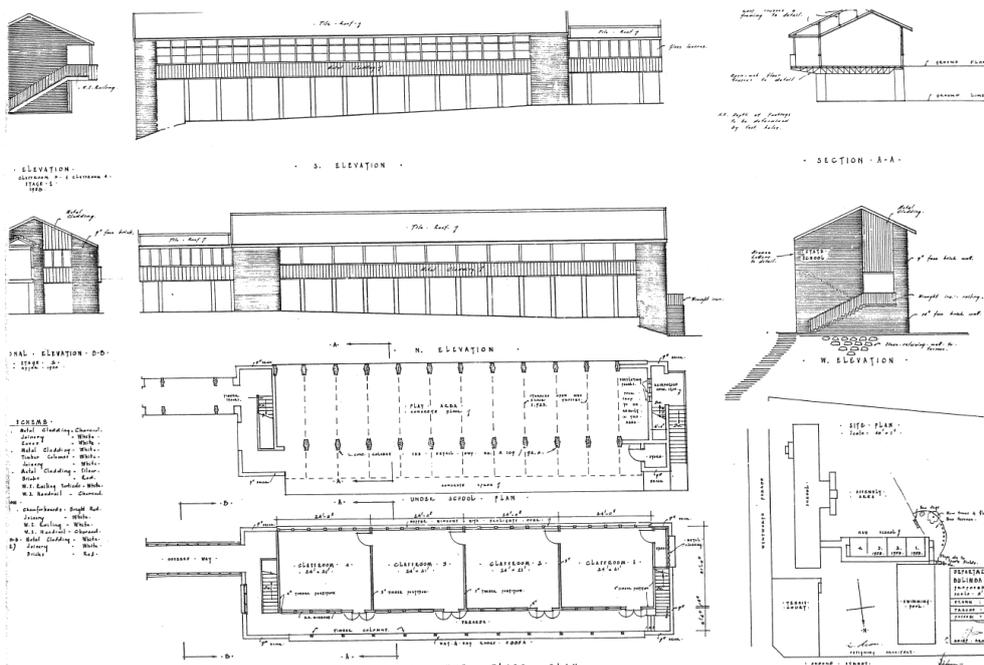
Figure 24: Proposed Block B 26 Nov 1958 [EHP]

Plans prepared for the building showed four classrooms perpendicular to Block A with only three classrooms to be built. The building construction was a standard post war design with the upper floor of classrooms supported on open web steel trusses to provide unobstructed playing space below. Concrete pillars were a typical lozenge shape. There was a verandah on the north side of the classrooms and banks of hopper windows on the south side. The end walls were of face brick and the roof was tiled. Balustrades were solid incorporating bag racks and were sheeted in metal cladding.

The plans include a specification for the building colours which were to be:

- Bricks - red
- Metal cladding – charcoal on the south and silver on the west
- Joinery and eaves – white
- Wrought iron railing - white with a charcoal handrail
- Chamferboards (at the east end before construction of the fourth classroom) – bright red – although the photo suggests they were painted a pale colour.

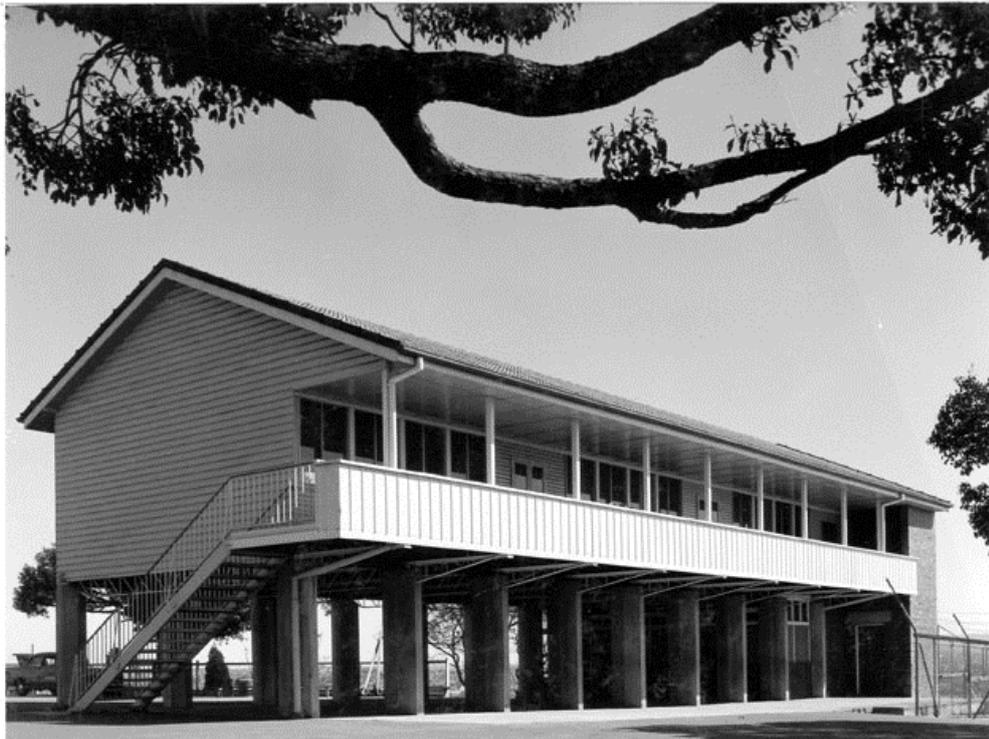
Figure 25: Block B in August 1960 (QSA image 15406). The fence at right is the swimming pool.
