BULIMBA STATE SCHOOL BRISBANE

HERITAGE REPORT: Section on history

Client: Department of Education and Training
Master Site Number: 20017
Address: 261 Oxford Street, Bulimba

Marie-Anne Ammons Architect Pty Ltd

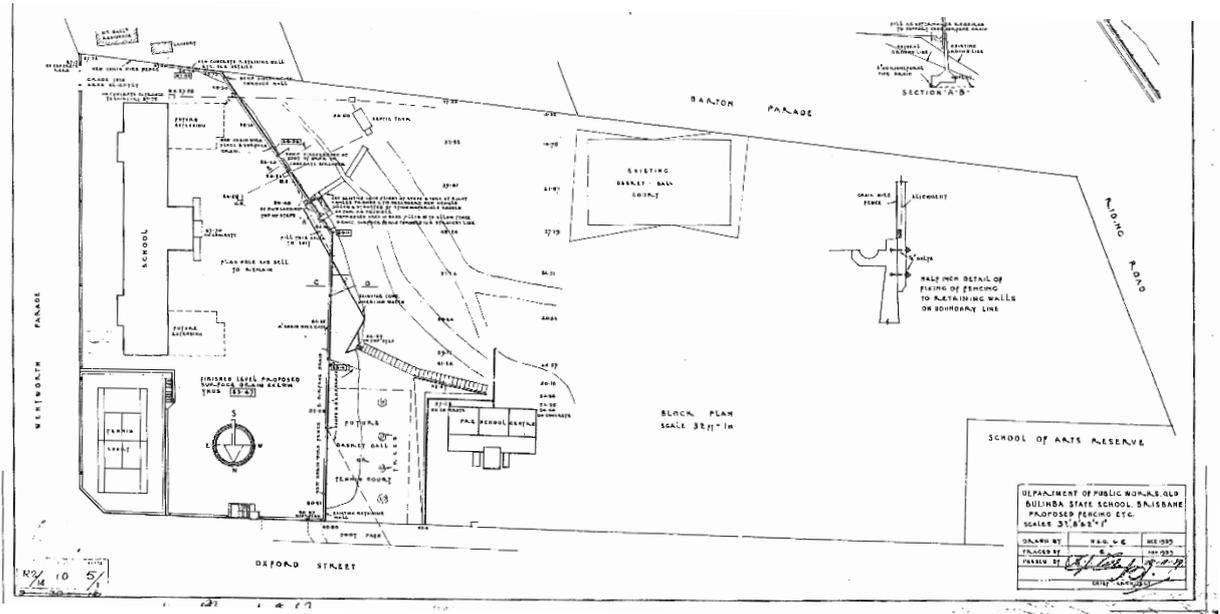
Figure 26: Part of a site plan prepared for the new retaining wall and fence around the western edge of the parade ground in 1939. A roughly excavated basket ball court is shown on the south boundary in the position of the existing courts and a new tennis court or basket ball court is proposed on the site of the swimming pool [EHP].

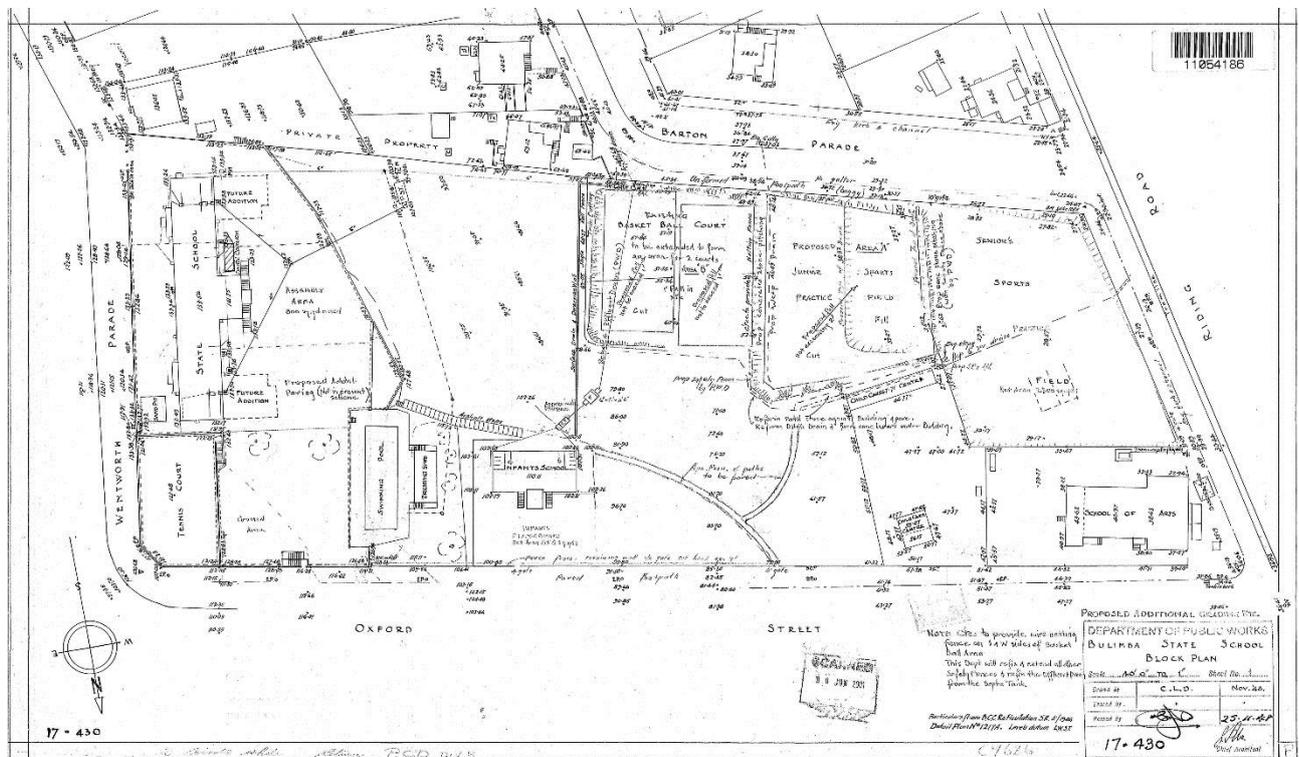
Figure 27: Site plan dated 1948 (eplan 11054186).

The plan in figure 27 is the most complete of several versions of the same drawing and includes the swimming pool in its current position. The plan also shows:

- Block A and the tennis court on the north east corner (built 1938)
- Entrance steps from Oxford Street to the upper terrace (built 1938)
- Swimming pool (eventually constructed 1954-55) with dressing sheds originally constructed out of timber. Extensive repairs to the swimming pool were carried out in the 1960s.

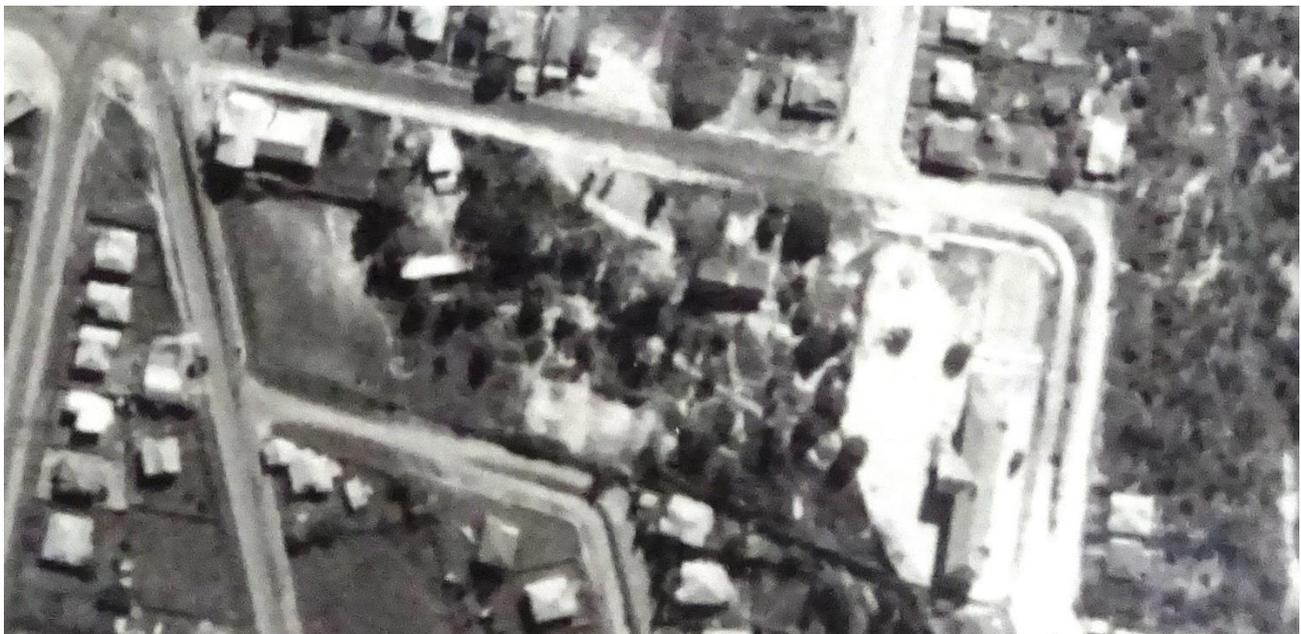
Figure 28: Aerial photograph dated 1946 (BCC H26C) showing Blocks A and C, the Child Care building, School of Arts building and mature trees. Note tree on East side of Block A.

The sequence of development after 1946 is shown in aerial photographs which follow.

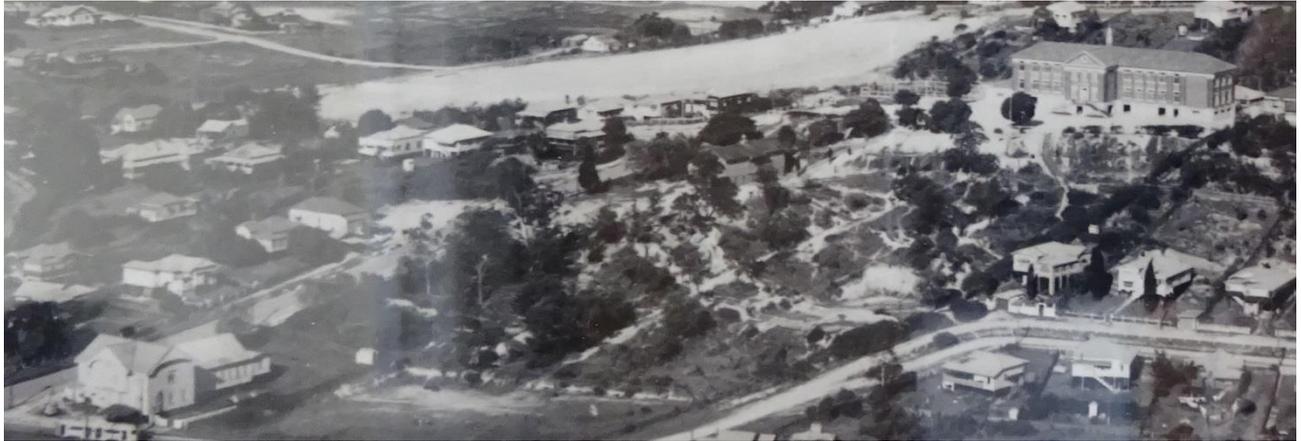
Figure 29: Photograph held by Bulimba School dated 1955. This photograph may be earlier than 1955 as it predates the installation of the hopper windows in the Infants' school which occurred in 1954. The fence of a tennis court built ca 1940 above the site of the existing swimming pool is visible.

Photographs up to 1960 show the area around A Block as open except for a few shade trees. Mature trees also grew in front of the Infants' School. The bottom oval is clearly defined but the basketball court on the south boundary is roughly formed. Much of the sloping ground on the southern side of the school is eroded with a maze of pathways crossing it.

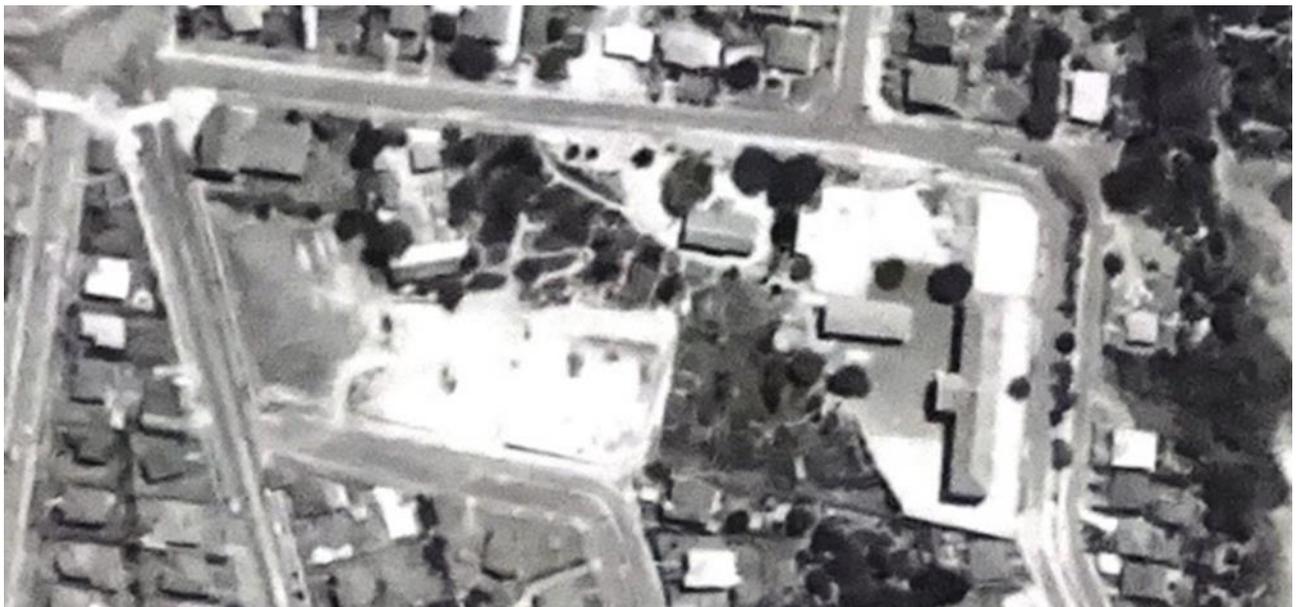
Figure 30: Aerial photograph date 1960 (BCC 227) showing Blocks A, B, C, the Child Care building, the School of Arts and cleared ground around the basketball courts and intermediate playing fields.

In the aerial photograph above the pale colour is probably decomposed granite; the darker area on the parade ground to the west of Block A is probably bitumen.

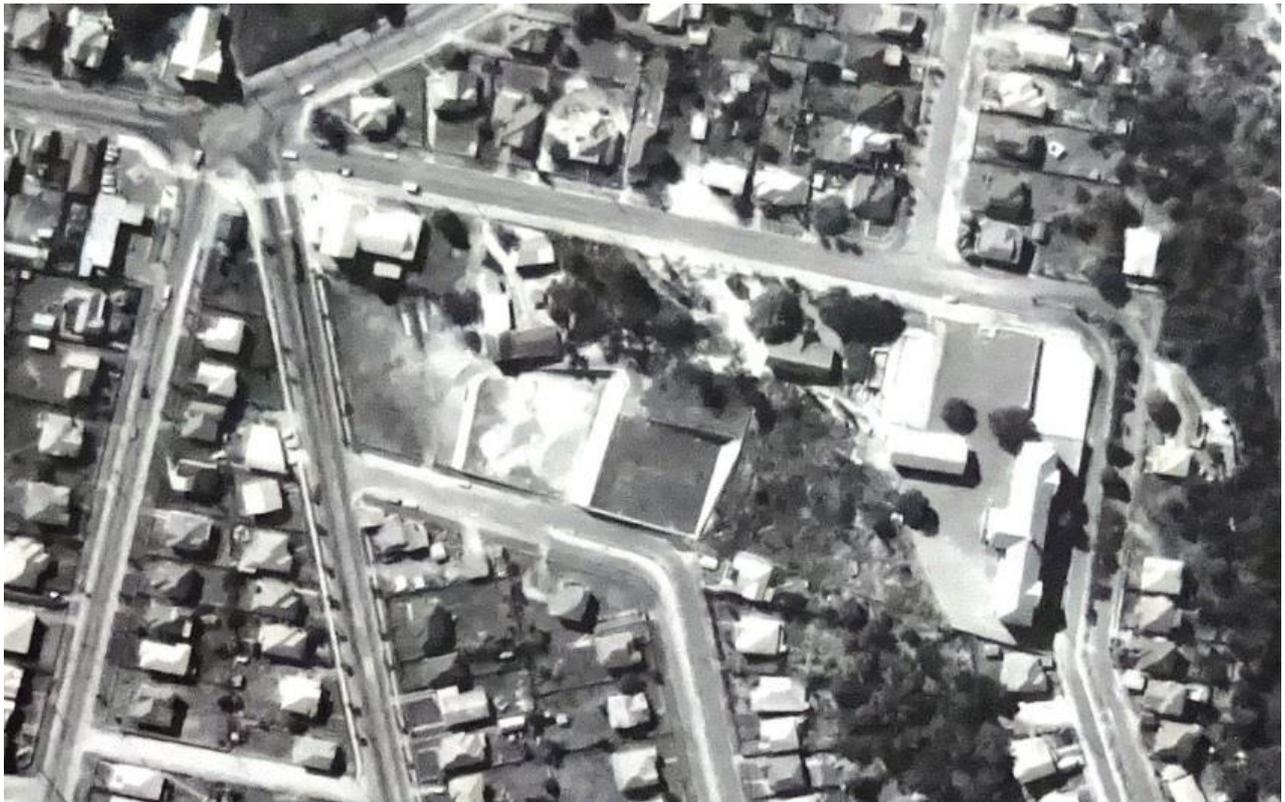
Figure 31: Aerial photograph 1964 (BCC 417) showing Blocks A, B, C, the pool, the Child Care building, School of Arts and masonry retaining walls around the intermediate playing fields. The trees in front of the Infants' School are probably figs, one was removed in 1968.

Concrete retaining walls around the basket ball courts and middle oval were constructed in 1961 and are shown in the aerial photograph for 1964.

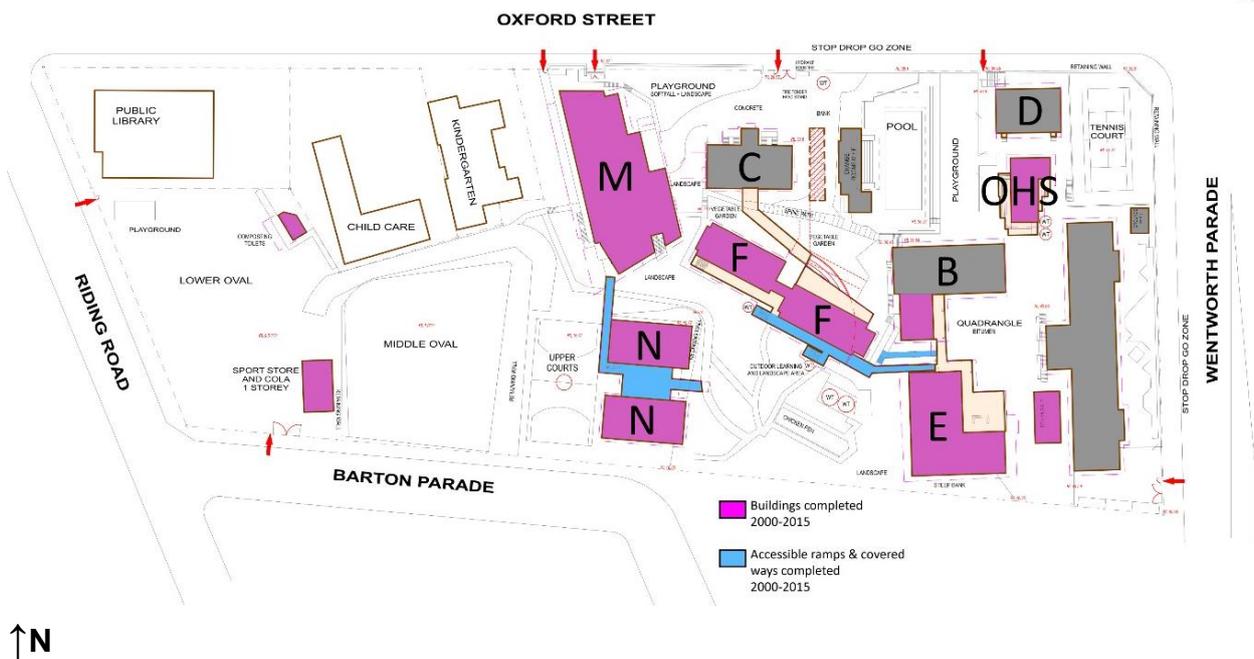
Figure 32: Diagram of buildings and accessible ramps completed 2000 – 2015 using base plan prepared by Biscoe Wilson Architects.

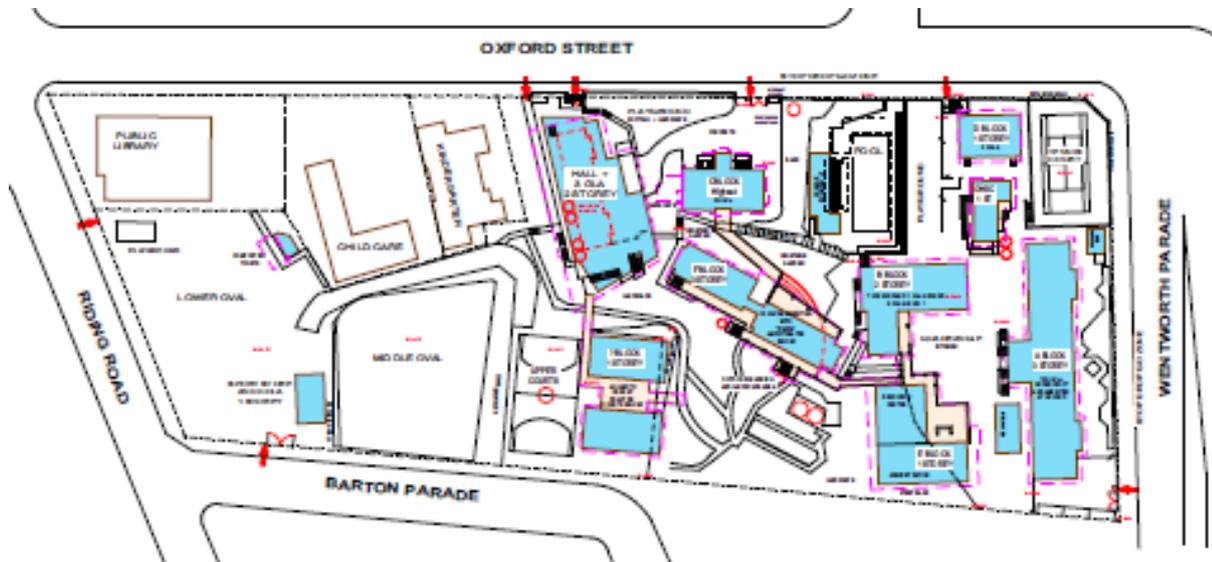
Figure 33: Site plan as existing prepared by Biscoe Wilson Architects 2015
